Test Report

No.: SHHL2302004074FT

Sample Description : AIRFORT 2.0 OFFICE CHAIR
Style No. : CCR-AF2A31AG-W
Supplier : KOKUYO FURNITURE (CHINA) CO.,LTD
Country of Origin : CHINA

Test Requested	Result
ANSI/BIFMA X5.1-2017 (R2022): GENERAL-PURPOSE OFFICE CHAIR- AMERICAN NATIONAL STANDARD FOR OFFICE FURNITURE	PASS

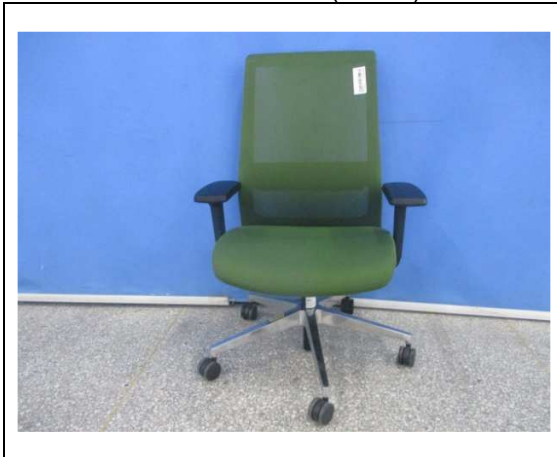
Received Chair (view 1)

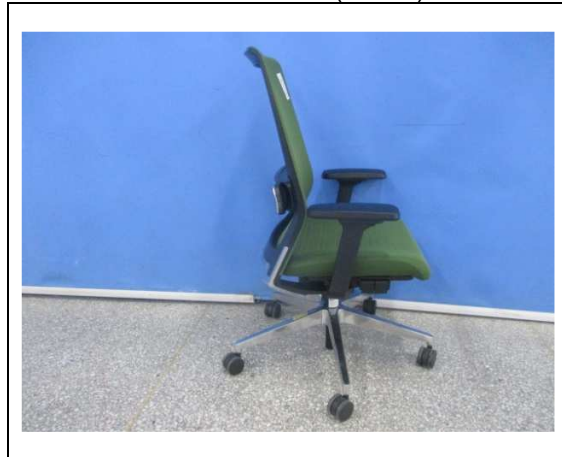
Received Chair (view 2)

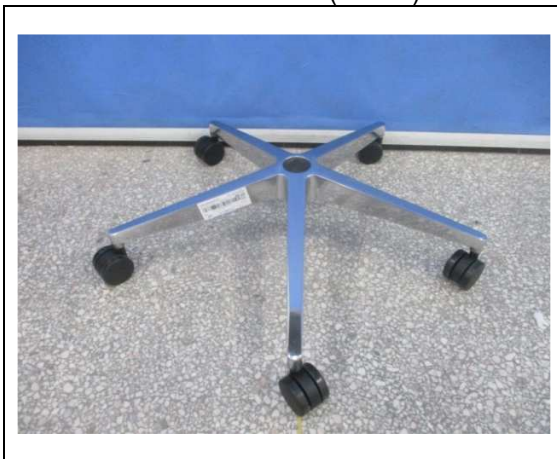
Received Base (view 1)

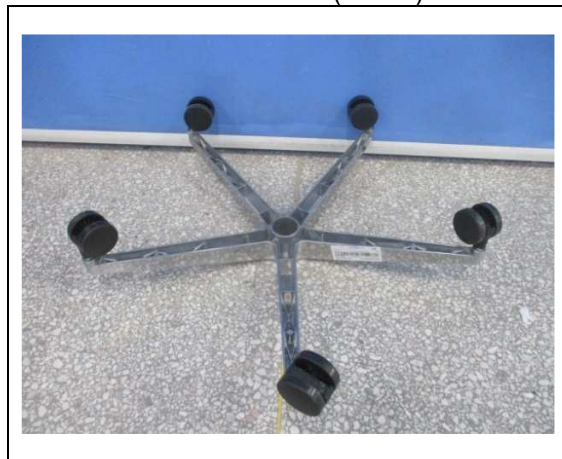
Received Base (view 2)
